Aviation Safety Department
2701 Forum Drive, D10
Grand Prairie, Texas 75052

AIRCRAFT WRECKAGE EXAM NOTES
Era Helicopters, Eurocopter AS250B2, S/N 3158
Sheep Mountain, Alaska
15 April 2008, 0923 LDT

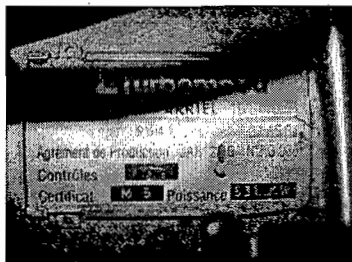
H. Powerplant

- The aircraft was powered by a Turbomeca Arriel 1D1 engine, S/N 9641.
- See Turbomeca accident report for more information.
